Engineering/Technical Investigation Report

Well Failure at Terra Wilder

December 2014

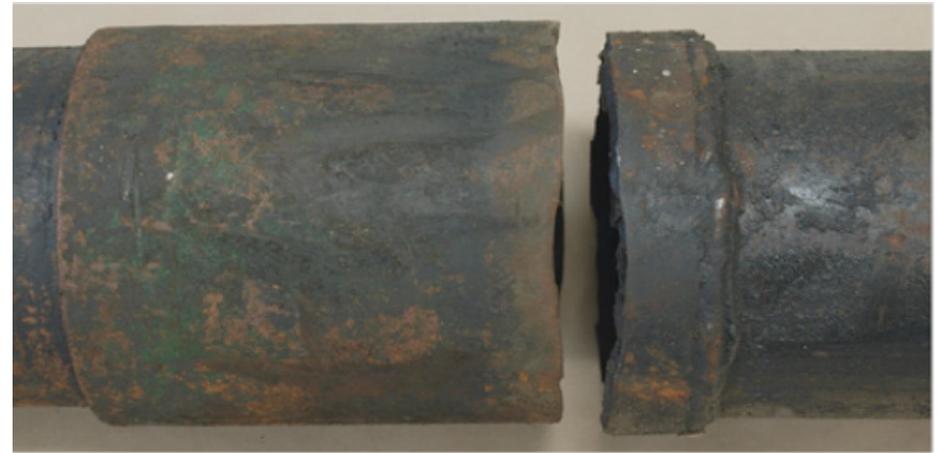
During the well abandonment in 1970, the well casing was cut and capped approximately 1 m below ground level. During the subsequent re-entry, the casing stub was exposed and a threaded collar was welded onto the casing to allow it to be extended back to ground level. The casing failure occurred where the collar was welded to the casing stub.

Rae determined the failure originated at the interface of the internal seal weld where the collar was welded onto the production casing and was caused by fatigue. The heat affected zones of the internal and external welds were found to have excessive hardness, making them susceptible to cracking. While there was no evidence of significant internal corrosion, Rae noted that the corrosive environment in the well likely accelerated crack propagation and the subsequent failure.

Excessive hardness of the weld and heat affected zones can result from rapid cooling of the weld. Pre-heating the metal prior to welding and controlling cooling after welding can prevent excessive hardness from developing.

Figure 2: Photograph showing the failed casing section.

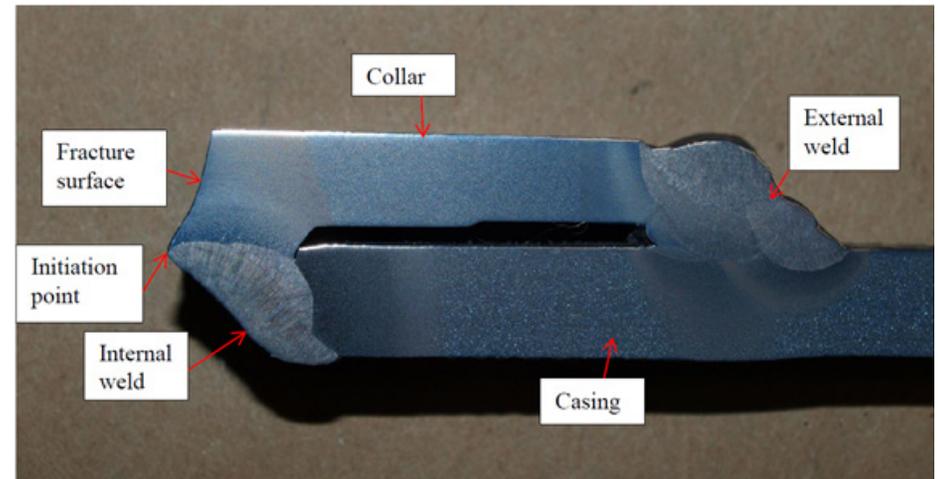
Figure 3: Photograph showing the cross section of failure location.

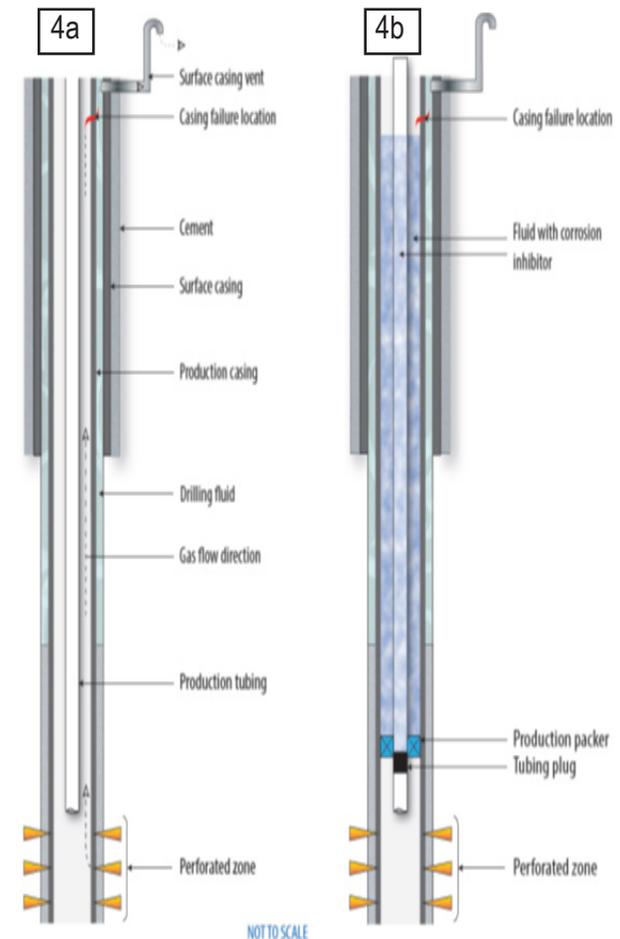
1. Failure to suspend the well in accordance with Commission requirements. Had the well been adequately suspended, the failed portion of casing would have been isolated from wellbore fluids.
2. Failure to inspect and pressure test the casing according to Commission requirements. An adequate inspection would have identified excessive pressure between the production casing and the tubing. Further investigation would have identified the well was not adequately suspended.

Figure 4a illustrates the actual well configuration at the time of the incident. Figure 4b illustrates the well configuration Terra provided to the Commission when

reporting the well was suspended and shows how the casing failure location would have been isolated from reservoir fluids.

Figure 4a: Actual wellbore configuration. 4b: Reported wellbore configuration
