# Failure Investigation Report

22 November 2009 Failure of Piping at  
EnCana Swan Wellsite A5-7-77-14 L W6M

February 4, 2010

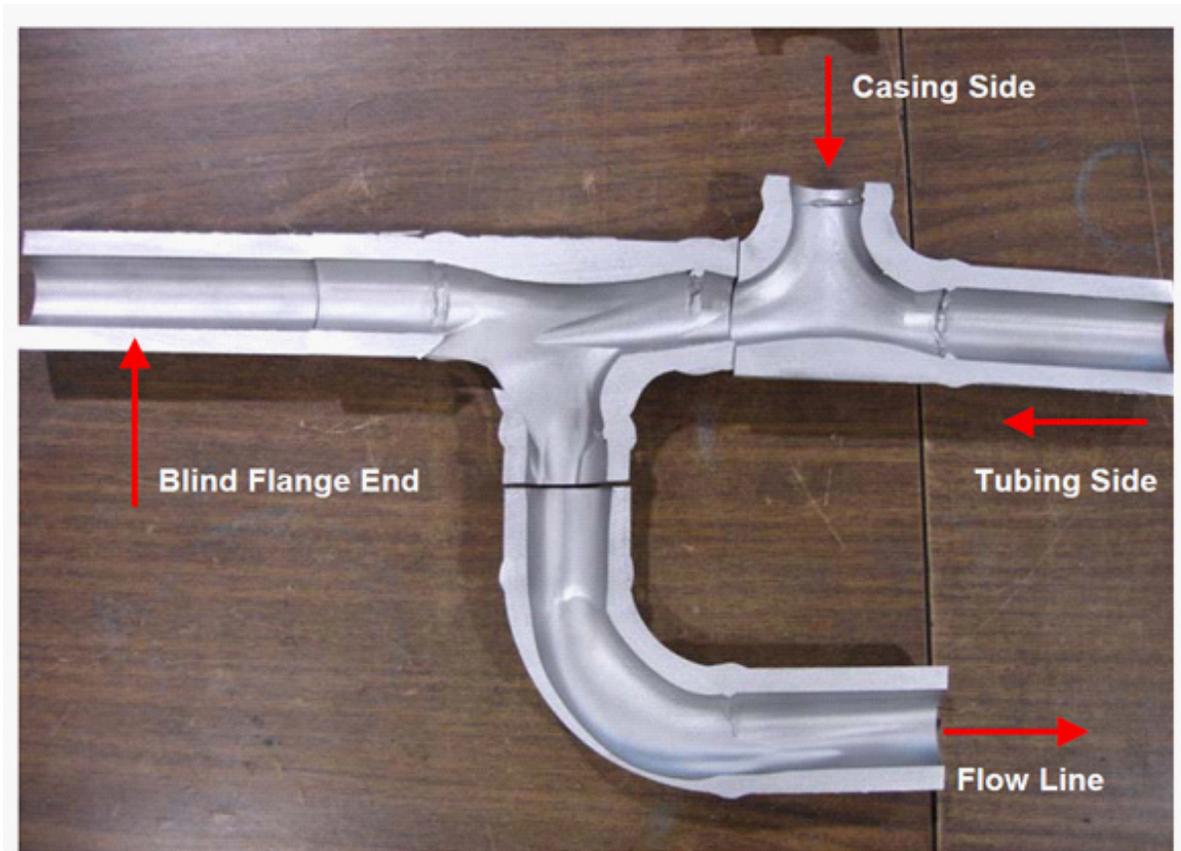
Figure 2 – Photograph of Eroded Tee

- The failed piping consisting of the failed tee (60.3 mm x 11.07 mm XXS A420-WPL6 tee) and the downstream elbow (see figure 2 on next page) exhibited significant internal erosion;

- A significant amount of sand was recovered from the failed piping and determined to be sand injected into the gas producing formation during fracture operations at this location;

Based on the preceding observations and statements, the Commission has determined the root cause of the piping failure which occurred the morning of 22 November 2009 at the EnCana well A05-07-077-14-W6M was internal erosion of the wall of the 60.3 mm x 11.07 mm XXS tee caused by flowing fracture sand suspended in the gas stream.

1. The 22 November 2009 failure of the A420 WPL-6 60.3 mm outside diameter (OD) x 11.07 mm wall thickness (WT) (XXS) tee at A5-7-77-14-W6M was caused by internal erosion of the wall resulting from flowing fracture sand suspended in the gas stream.

1. EnCana shall place emergency shutdown (ESD) valves immediately adjacent to (within one metre of) the wellhead at all wellsites within British Columbia where internal abrasion from sand returns may present a hazard. At these locations, bends between the wellhead and the ESD valves are not permitted. EnCana shall review the location of ESD valves at all existing wells within British Columbia and shall file with the Commission a plan for the necessary modifications. The plan shall be filed with the Commission for approval on or before 30 May 2010.
