Failure Investigation Report

Final report on the Nov. 22, 2009 Failure of Piping at
Encana Swan Wellsite A5-7-77-14 L W6M

November 2010

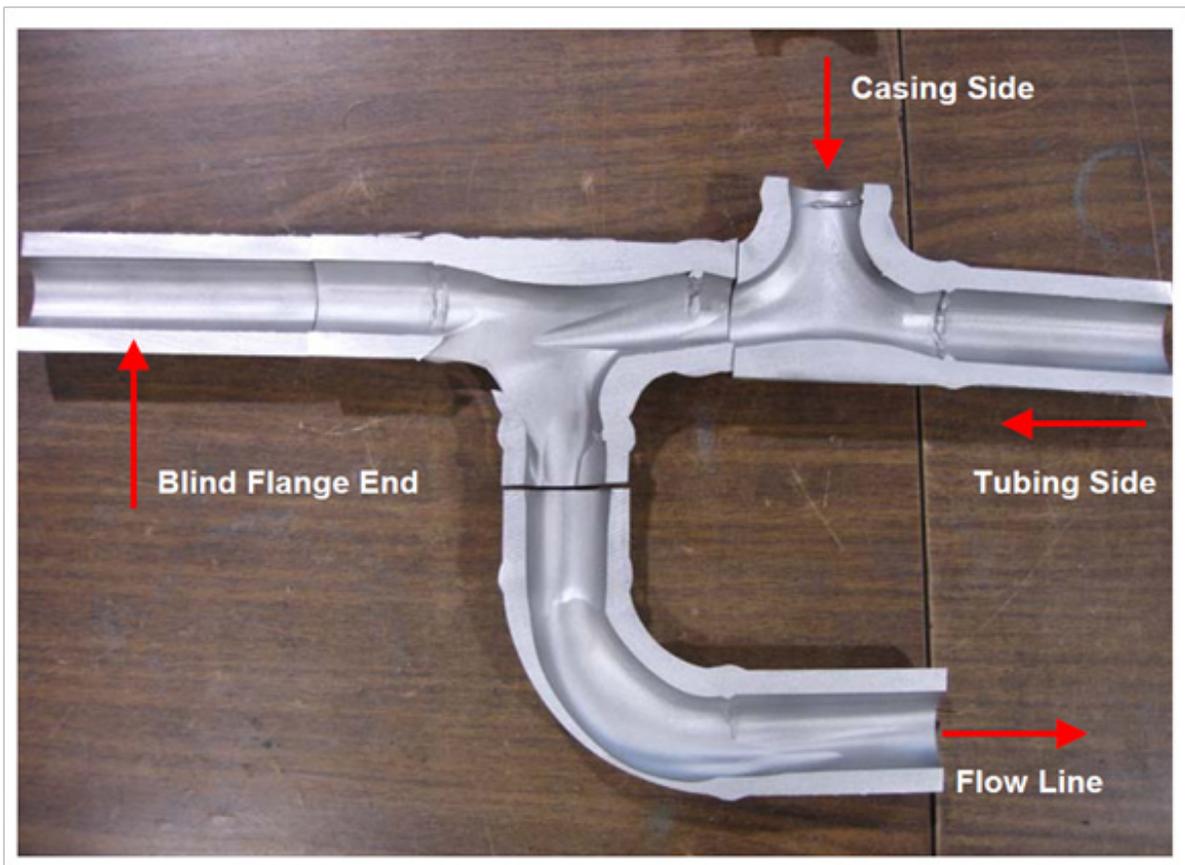
Figure 2 – Photograph of Eroded Tee

- The failed piping consisting of the failed tee (60.3 mm x 11.07 mm XXS A420-WPL6 tee) and the downstream elbow (Figure 2) exhibited significant internal erosion.

- A significant amount of sand was recovered from the failed piping and determined to be sand injected into the gas-producing formation during fracture operations at this location.

Based on the preceding observations and statements, the Commission has determined the root cause of the piping failure that occurred the morning of Nov. 22, 2009 at the Encana well A05-07-077-14-W6M was internal erosion of the wall of the 60.3 mm x 11.07 mm XXS tee caused by flowing fracture sand suspended in the gas stream.

1. The Nov. 22, 2009 failure of the A420 WPL-6 60.3 mm outside diameter (OD) x 11.07 mm wall thickness (WT) (XXS) tee at A5-7-77-14-W6M was caused by internal erosion of the wall resulting from flowing fracture sand suspended in the gas stream.

1. Encana shall place emergency shutdown (ESD) valves immediately adjacent to (within one metre of) the wellhead at all wellsites within British Columbia where internal abrasion from sand returns may present a hazard. At these locations, bends between the wellhead and the ESD valves are not permitted. Encana shall review the location of ESD valves at all existing wells within British Columbia and shall file with the Commission a plan for the necessary modifications. The plan shall be filed with the Commission for approval on or before May 30, 2010.
