Failure Investigation Report

January 10, 2010 Third Party Damage
to Terasen Gas Line at Bay Street
and Pleasant Street, Victoria, B.C.

September 1, 2011

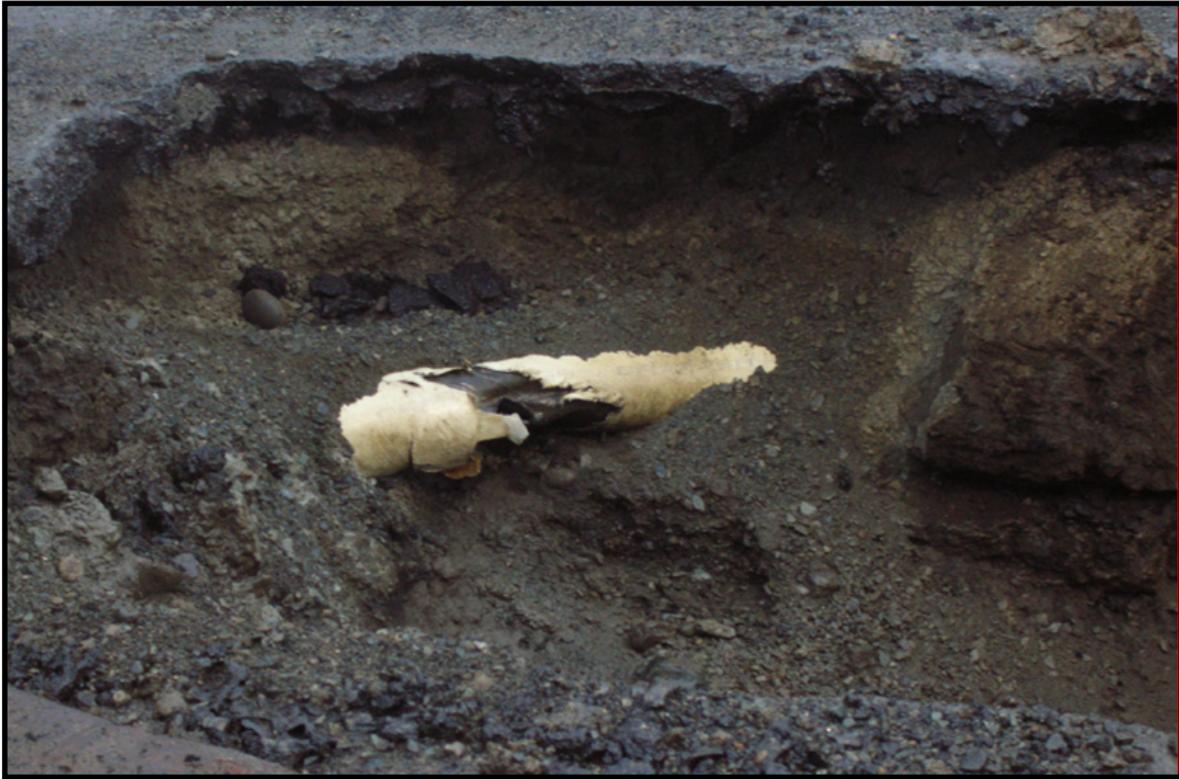
Figure 3 – Damaged Pipe

On the evening of January 10, 2010, at approximately 10:20 pm, a 168.3 mm nominal pipe size (NPS) x 4.8 mm wall thickness (WT) Grade 245.1, Category 1, Intermediate Pressure 1,900 kPa (275 psi) natural gas pipeline, owned by Terasen was struck and punctured by the Contractor while working at the intersection of Bay Street and Pleasant Street in Victoria, B.C. Figure 2 provides a spatial view of the incident location and surrounding roads and Figure 3 shows the damaged pipe.

Based on the available information, the Commission has determined the root cause of the piping damage that released natural gas for 12 hours on the evening of January 10, 2010 at Bay Street and Pleasant Street in Victoria, B.C. was third party mechanical damage resulting from the failure to follow required

procedures for excavation near intermediate pressure pipelines. The Contractor did not confirm the location of underground utilities prior to excavating and did not obtain a pipeline permit in accordance with Terasen requirements for crossing or excavating within two m of an IP pipeline.
