Failure Investigation Report

January 10, 2010 Third Party Damage
to Terasen Gas Line at Bay Street
and Pleasant Street, Victoria, B.C.

September 1, 2011

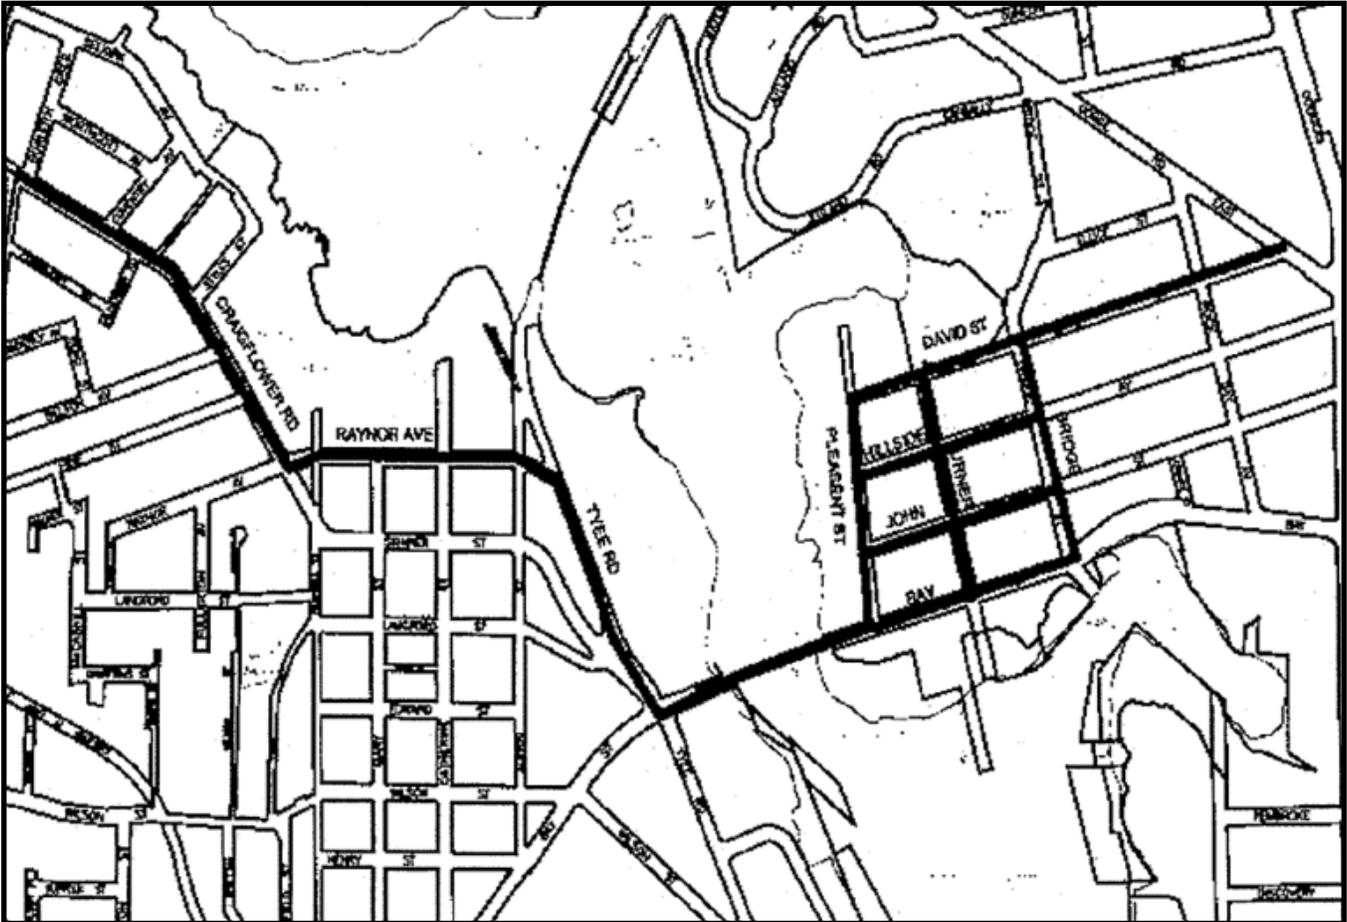
Figure 1 – Proposed waterline removal and replacement project

In 2009, AECOM Canada (the Consultant) commenced a project to remove and replace waterlines for the Greater Victoria Capital Regional District (the Municipality). G&E Equipment Rentals (the Contractor) was contracted by the Consultant to carry out the excavation for the waterline removal and replacement. The replacement was to take place from Dominion Road along Craigflower Road, Raynor Avenue, Tye Road, Bay Street, Pleasant Street, Bridge Street, and David Street; and along David Street between Pleasant Street and Gorge Road. Figure 1 shows the water main plan.

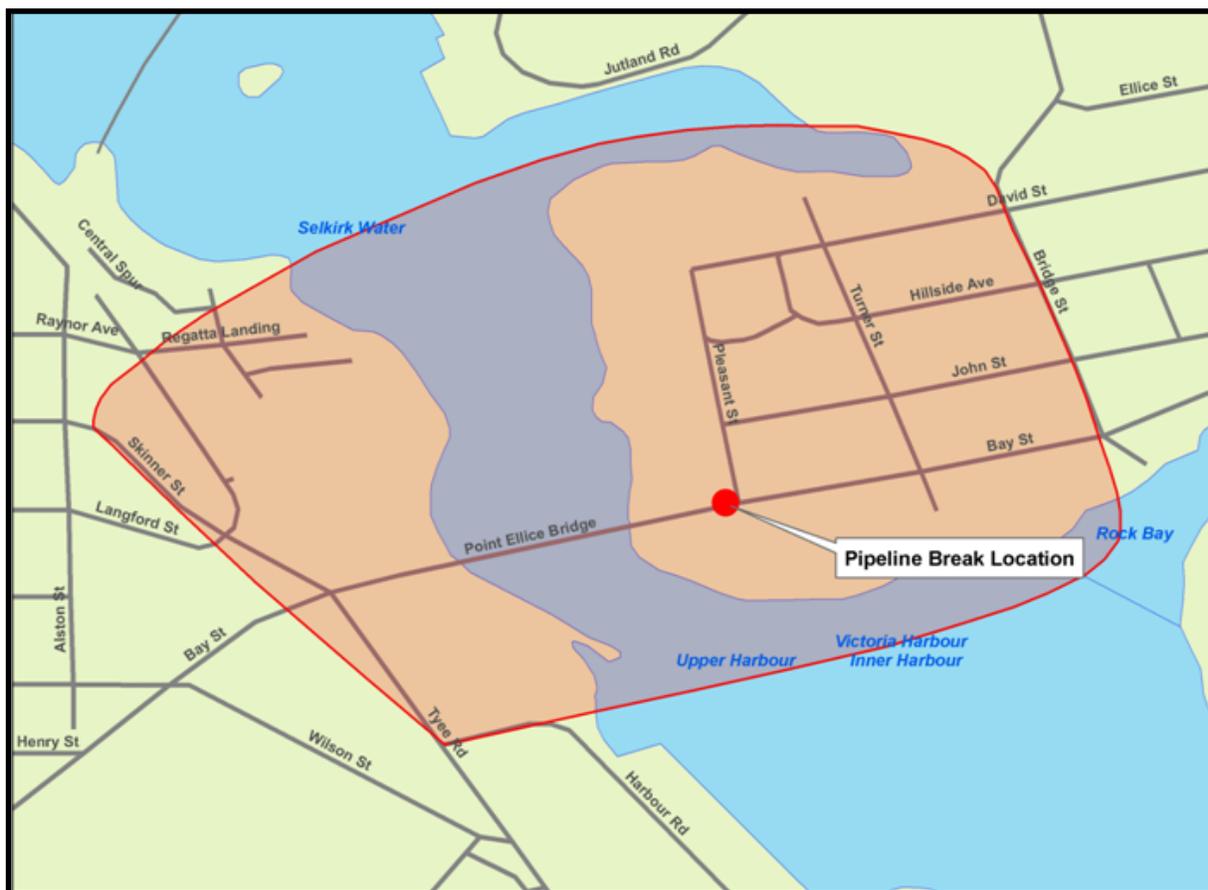
Figure 2 – Incident Location

On the evening of January 10, 2010, at approximately 10:20 pm, a 168.3 mm nominal pipe size (NPS) x 4.8 mm wall thickness (WT) Grade 245.1, Category 1, Intermediate Pressure 1,900 kPa (275 psi) natural gas pipeline, owned by Terasen was struck and punctured by the Contractor while working at the intersection of Bay Street and Pleasant Street in Victoria, B.C. Figure 2 provides a spatial view of the incident location and surrounding roads and Figure 3 shows the damaged pipe.
